RC
1042
.M38
1990a
c.2

Department
of Transportation
National Highway
Traffic Safety
Administration

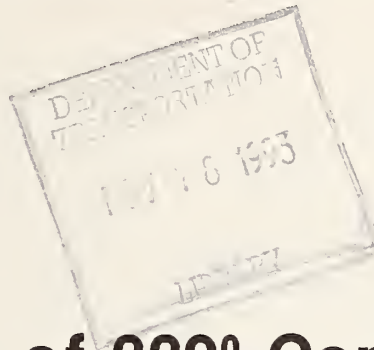
Final Report of 339° Contoured Moving Barrier Impact Into a 1985 Ford Escort 3-Door Hatchback in Support of Crash III Damage Algorithm Reformation

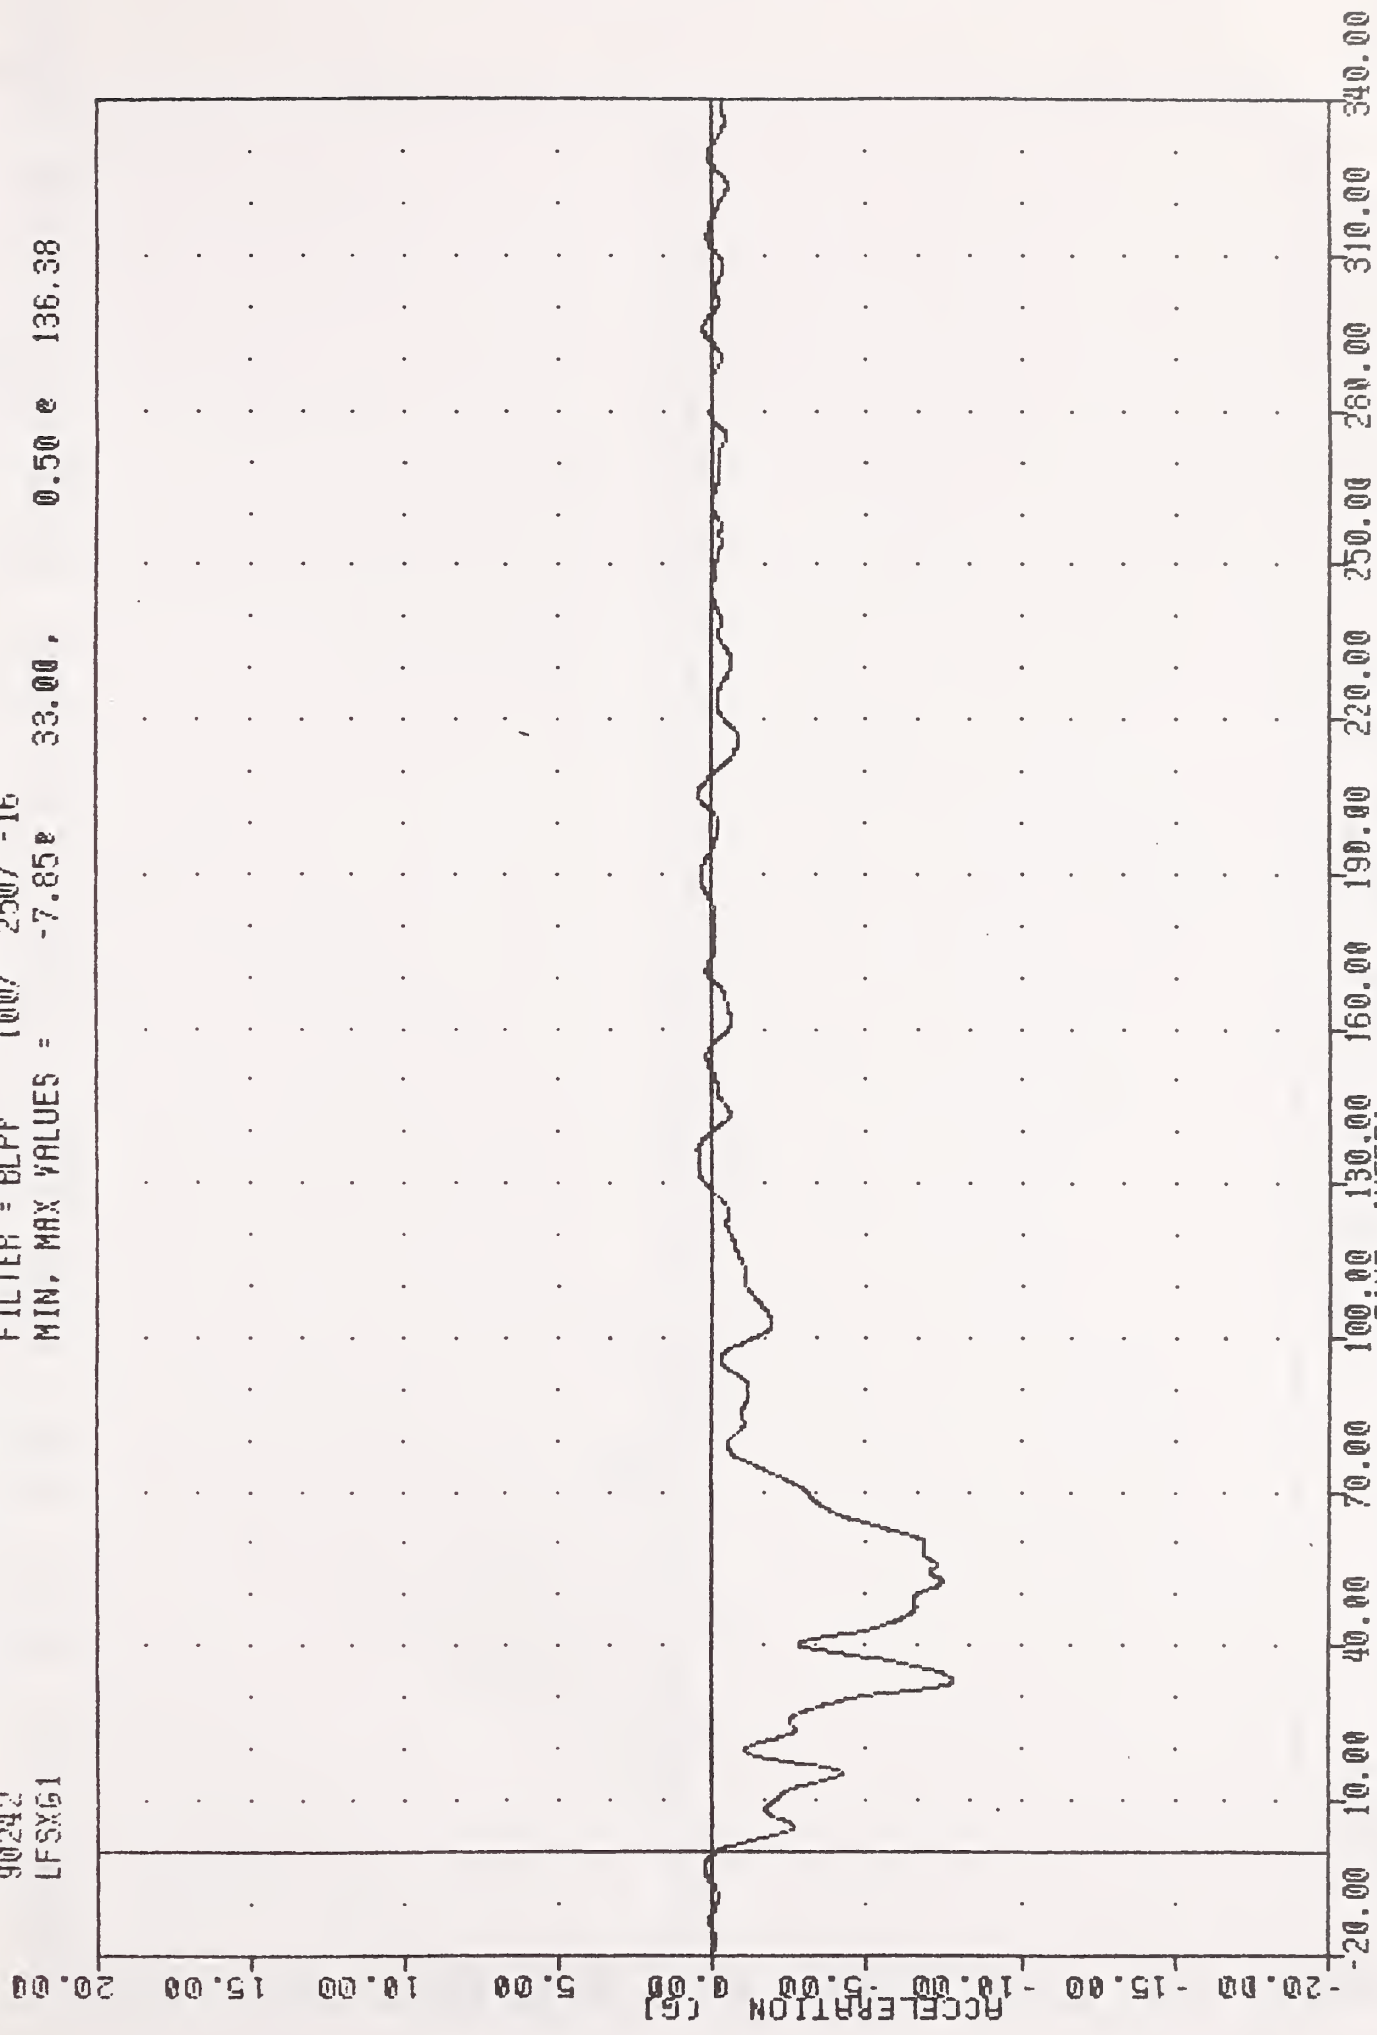
CONTOURED MOVING BARRIER INTO FORD ESCORT AT 14.2 MPH #1
 LEFT FRONT SILL X-AXIS ACCELERATION

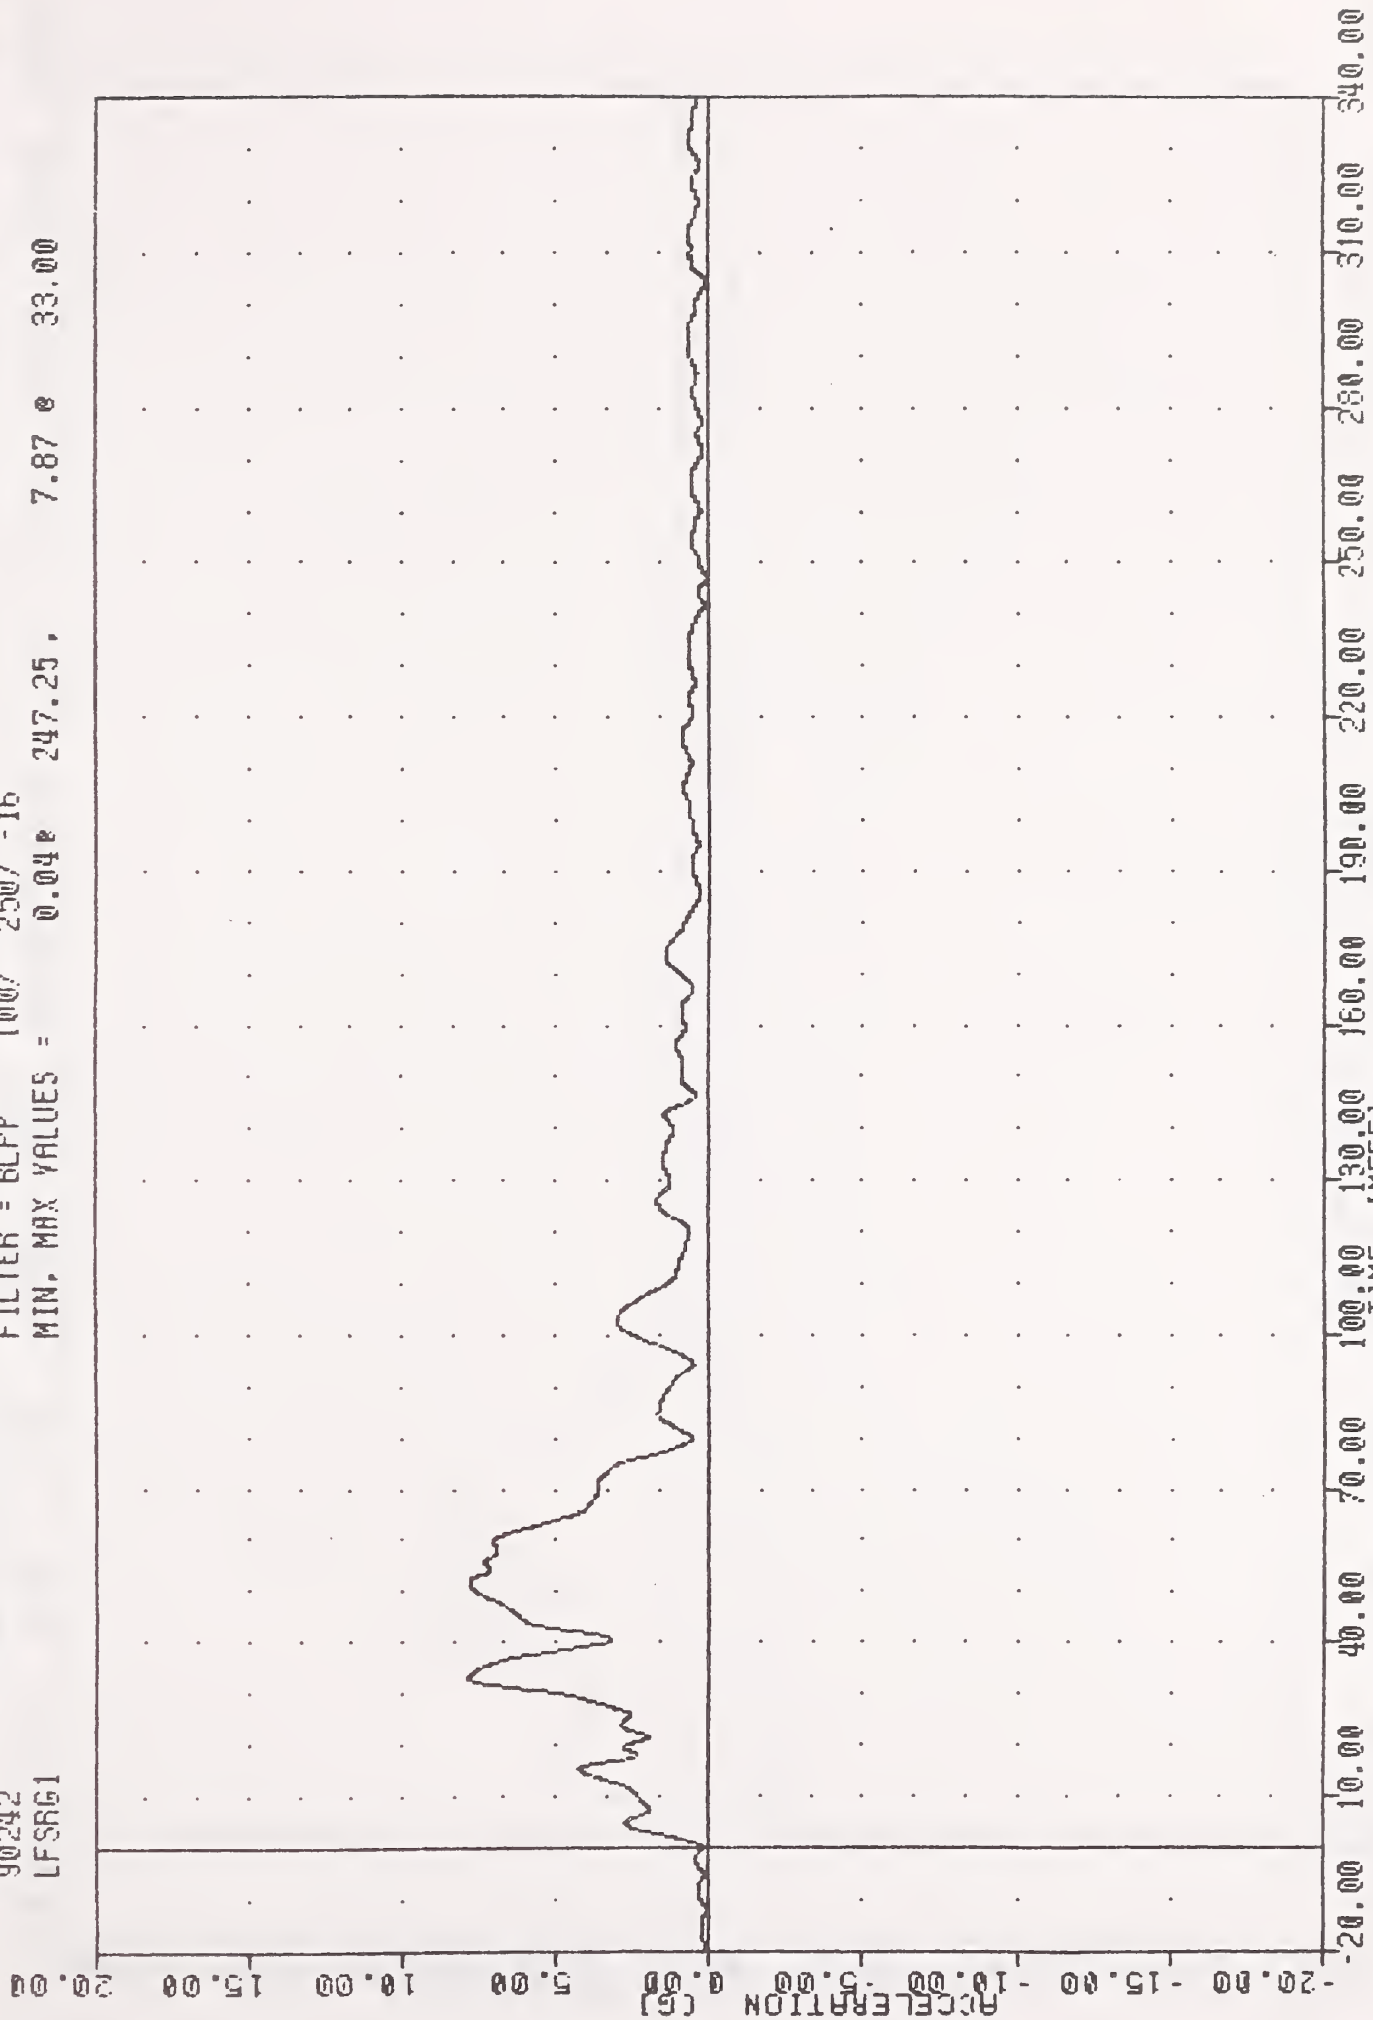
CONTOURED MOVING BARRIER INTO FORD ESCORT AT 14.2 MPH #1
 LEFT FRONT SILL RESULTANT ACCELERATION

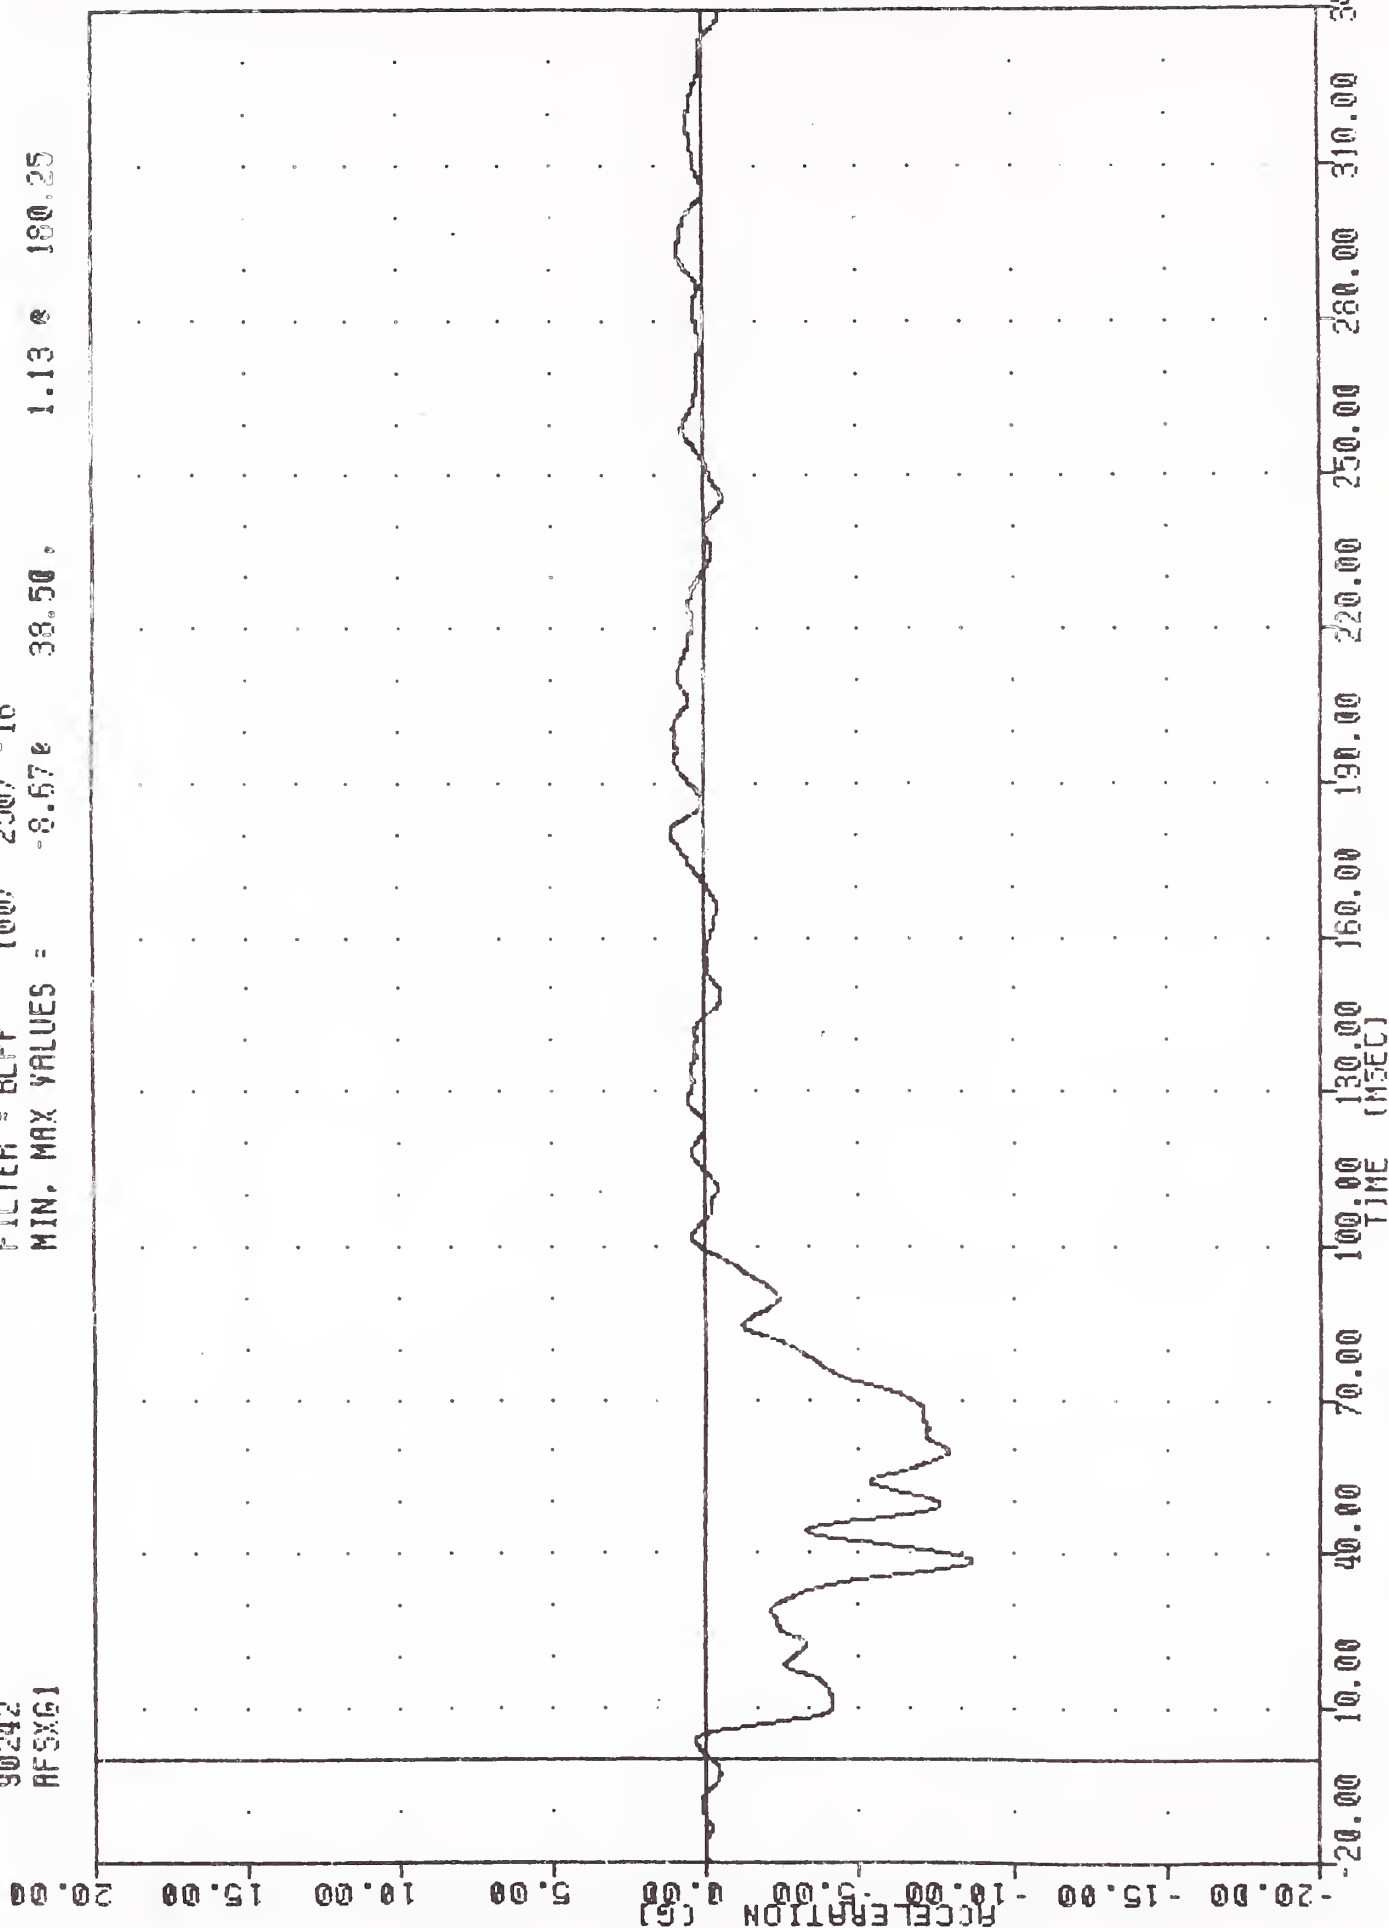
CONTOURED MOVING BARRIER INTO FORD ESCORT AT 14.2 MPH #1
RIGHT FRONT SILL X-AXIS ACCELERATION

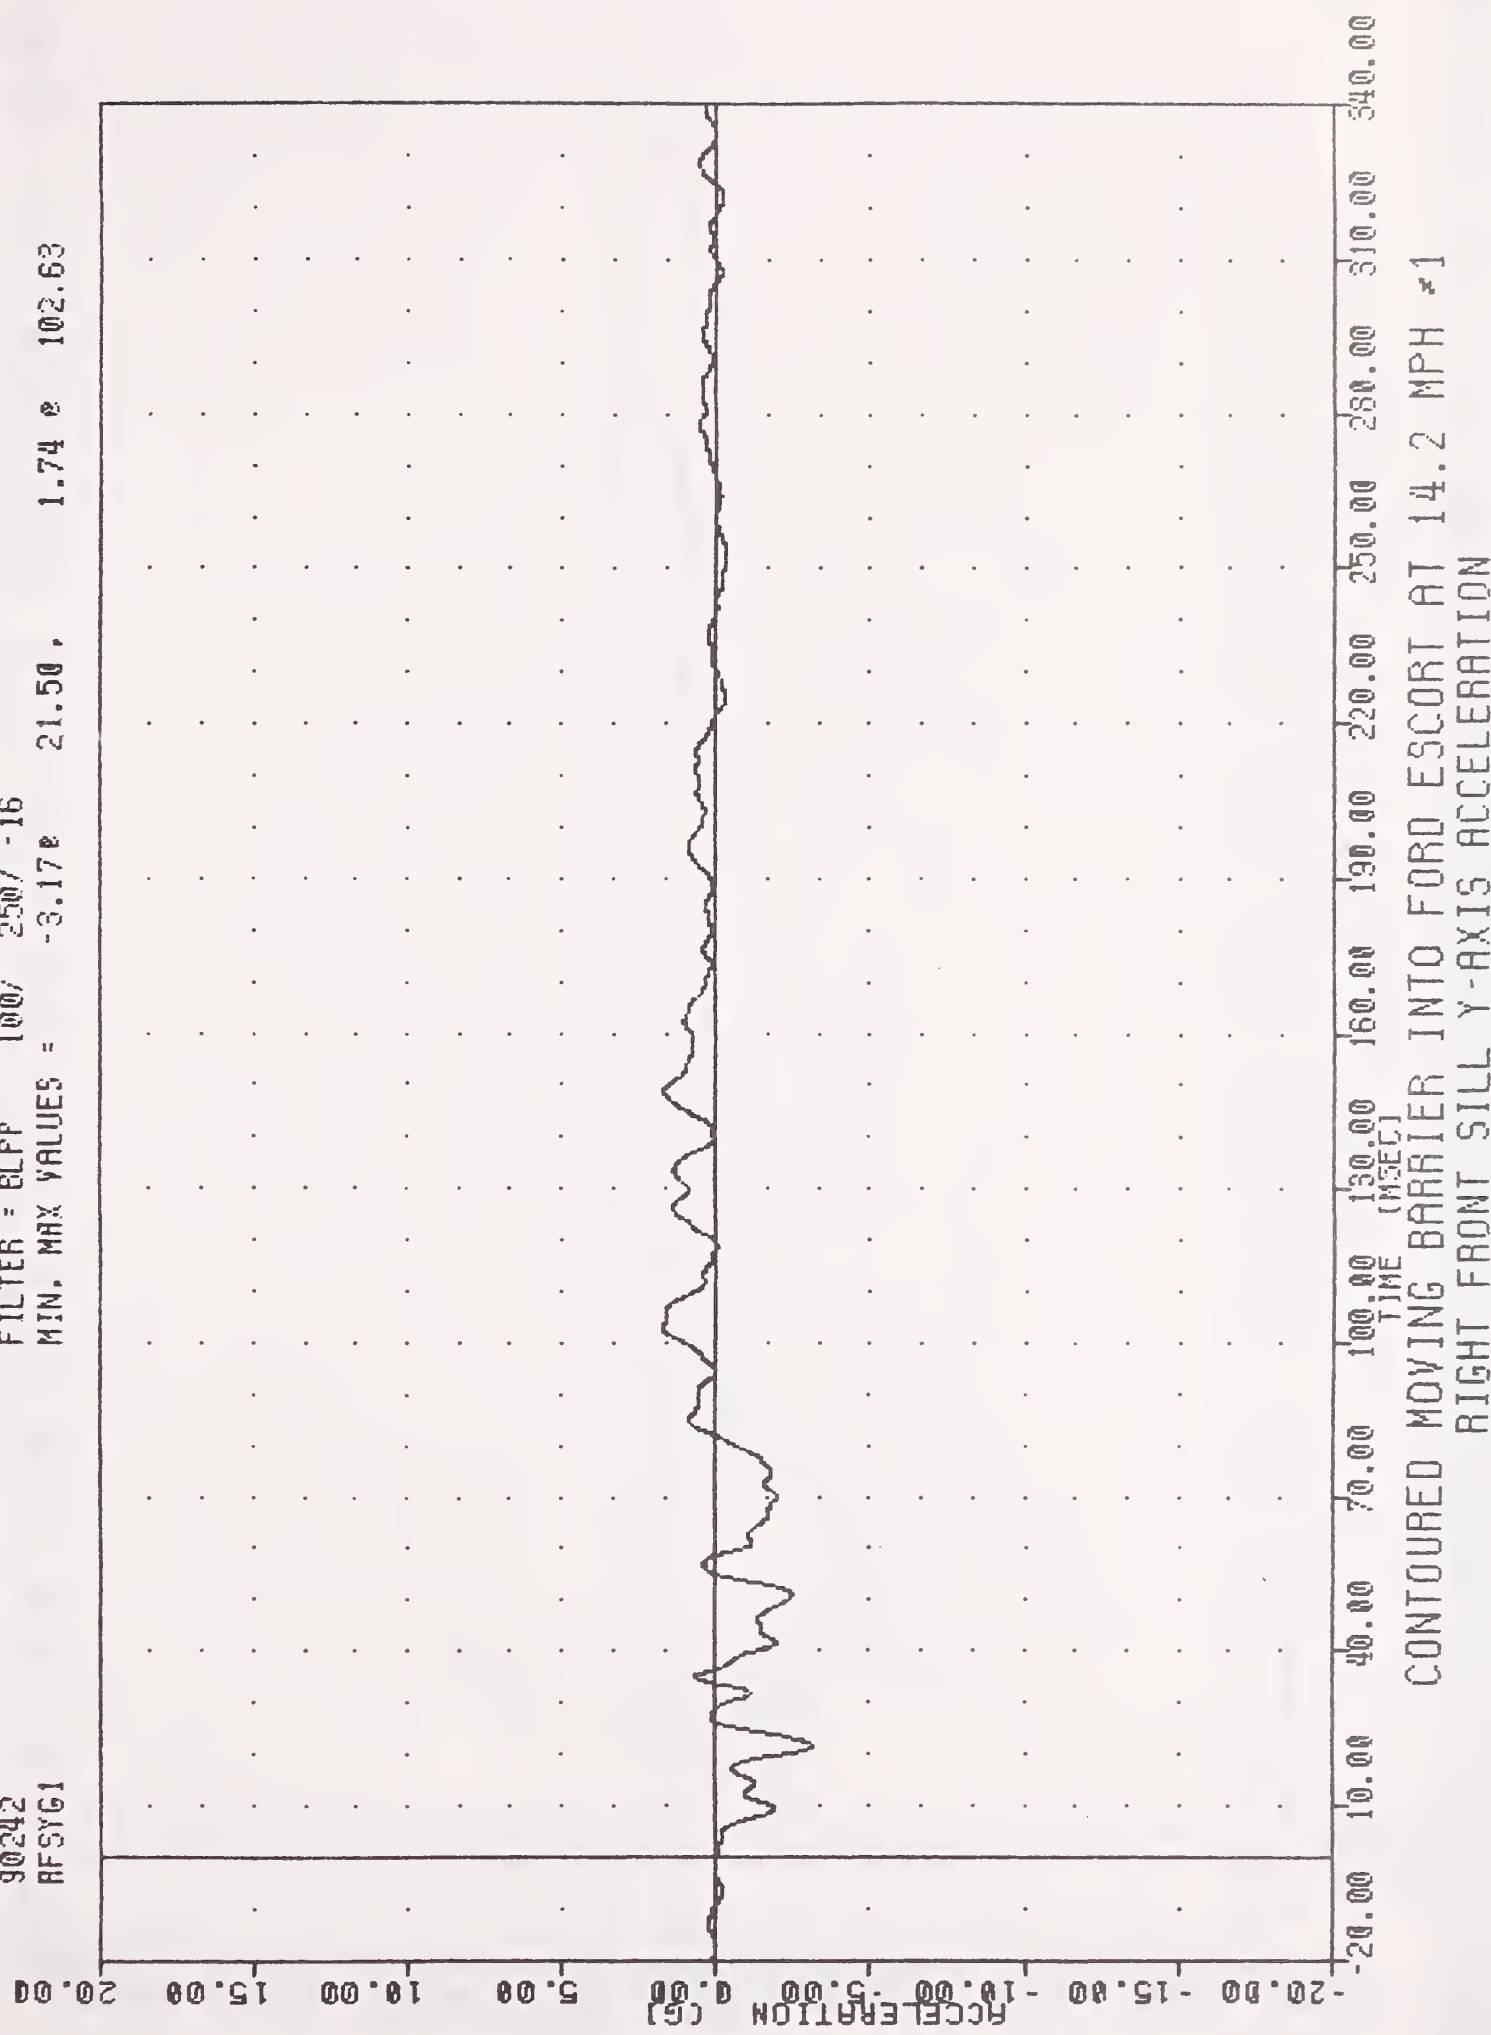
900330-1 , TRC
 CRASH III DAMAGE ALGORITHM
 90242
 RFSRG1

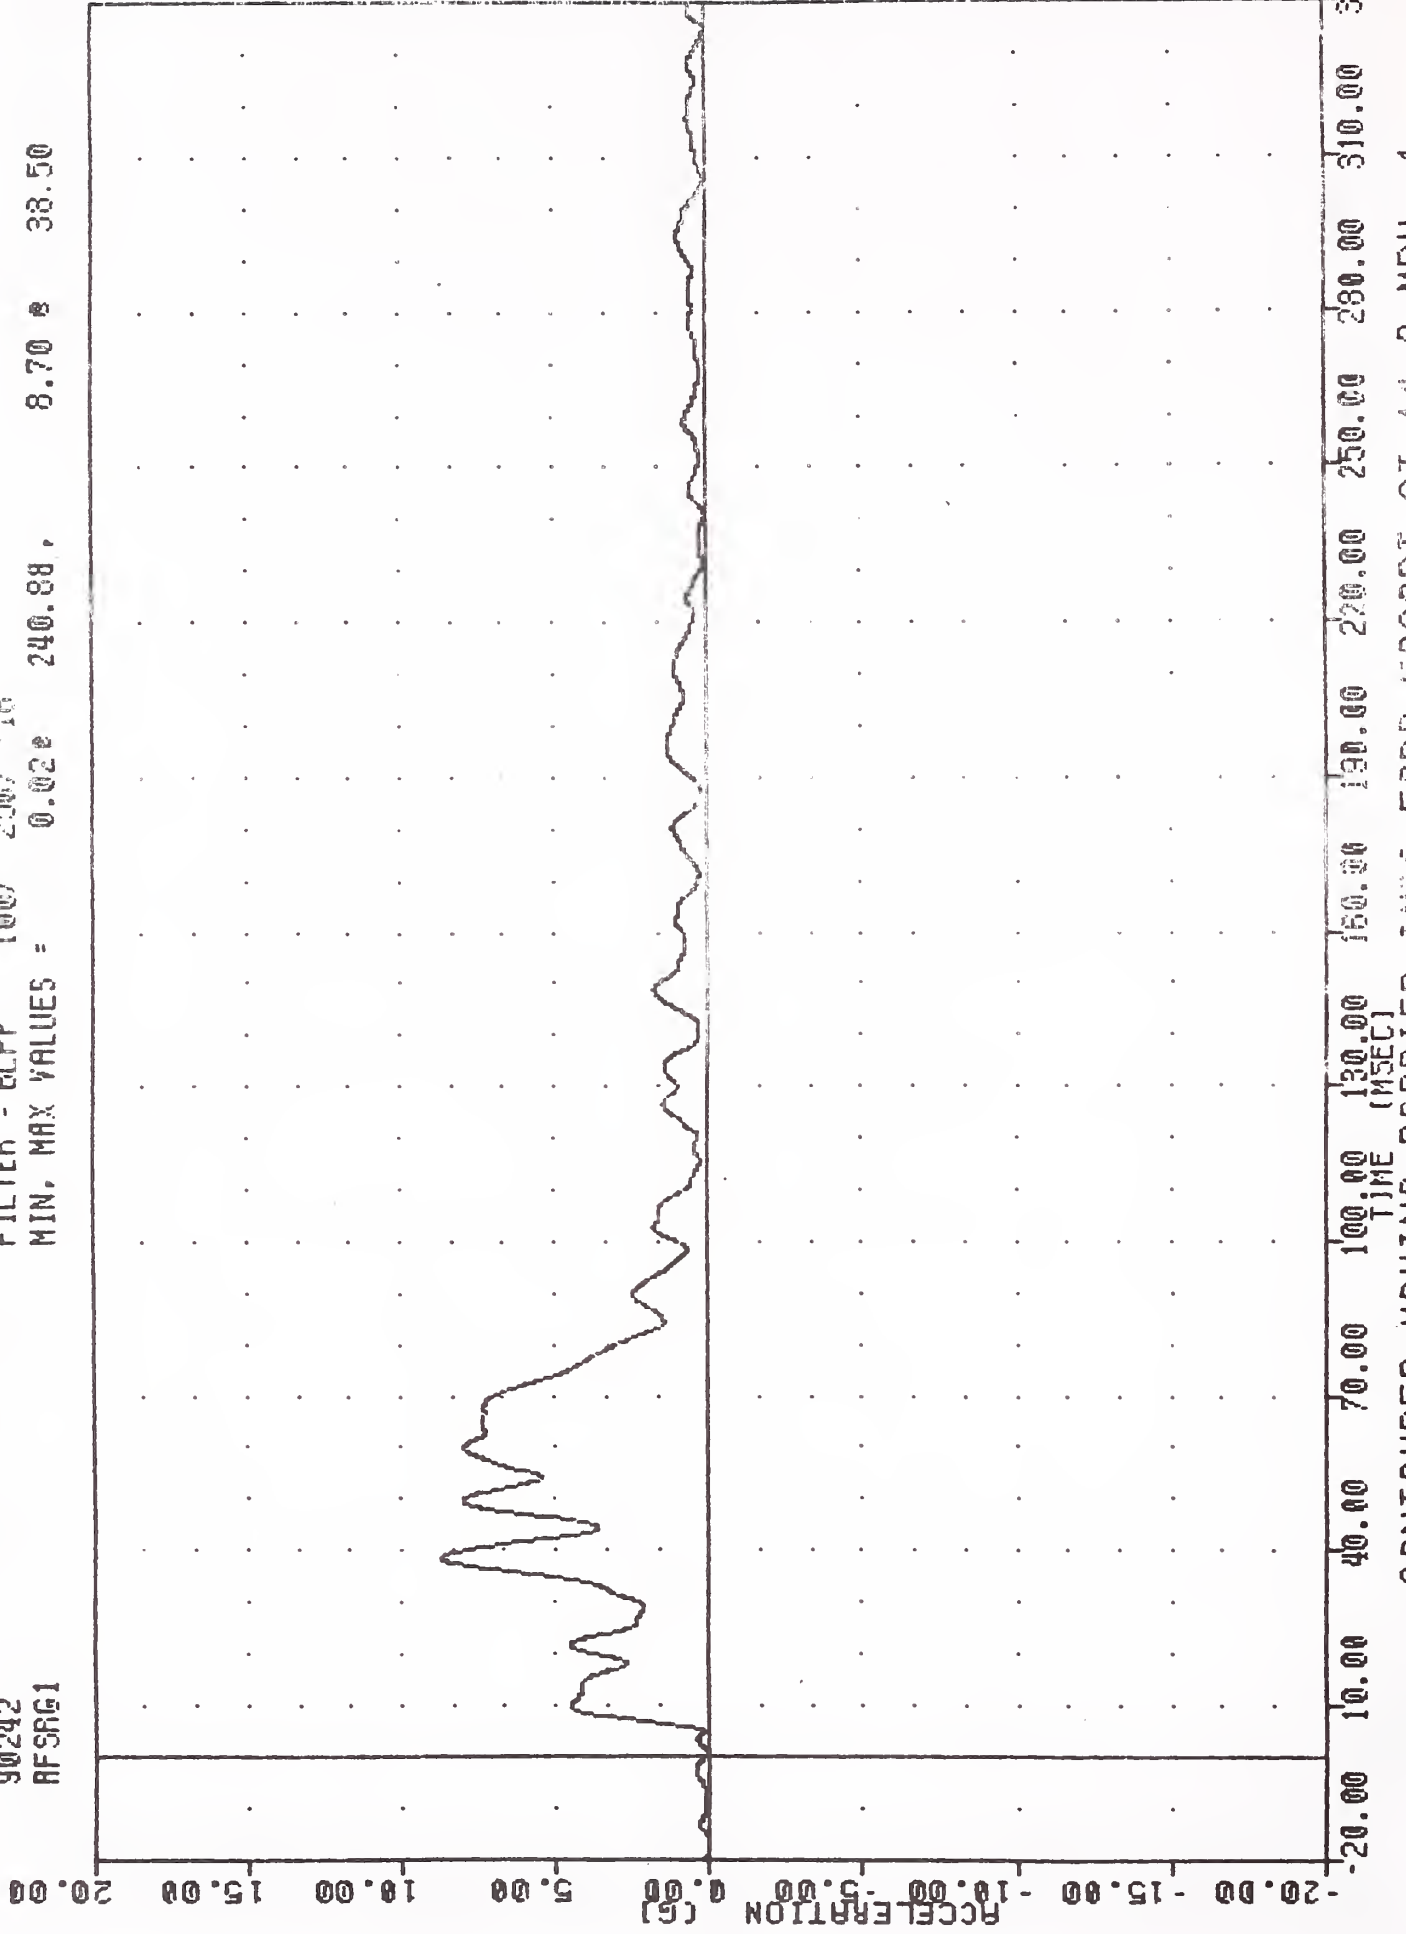
CONTOURED MOVING BARRIER INTO FORD ESCORT AT 14.2 MPH #1
 RIGHT FRONT SILL RESULTANT ACCELERATION

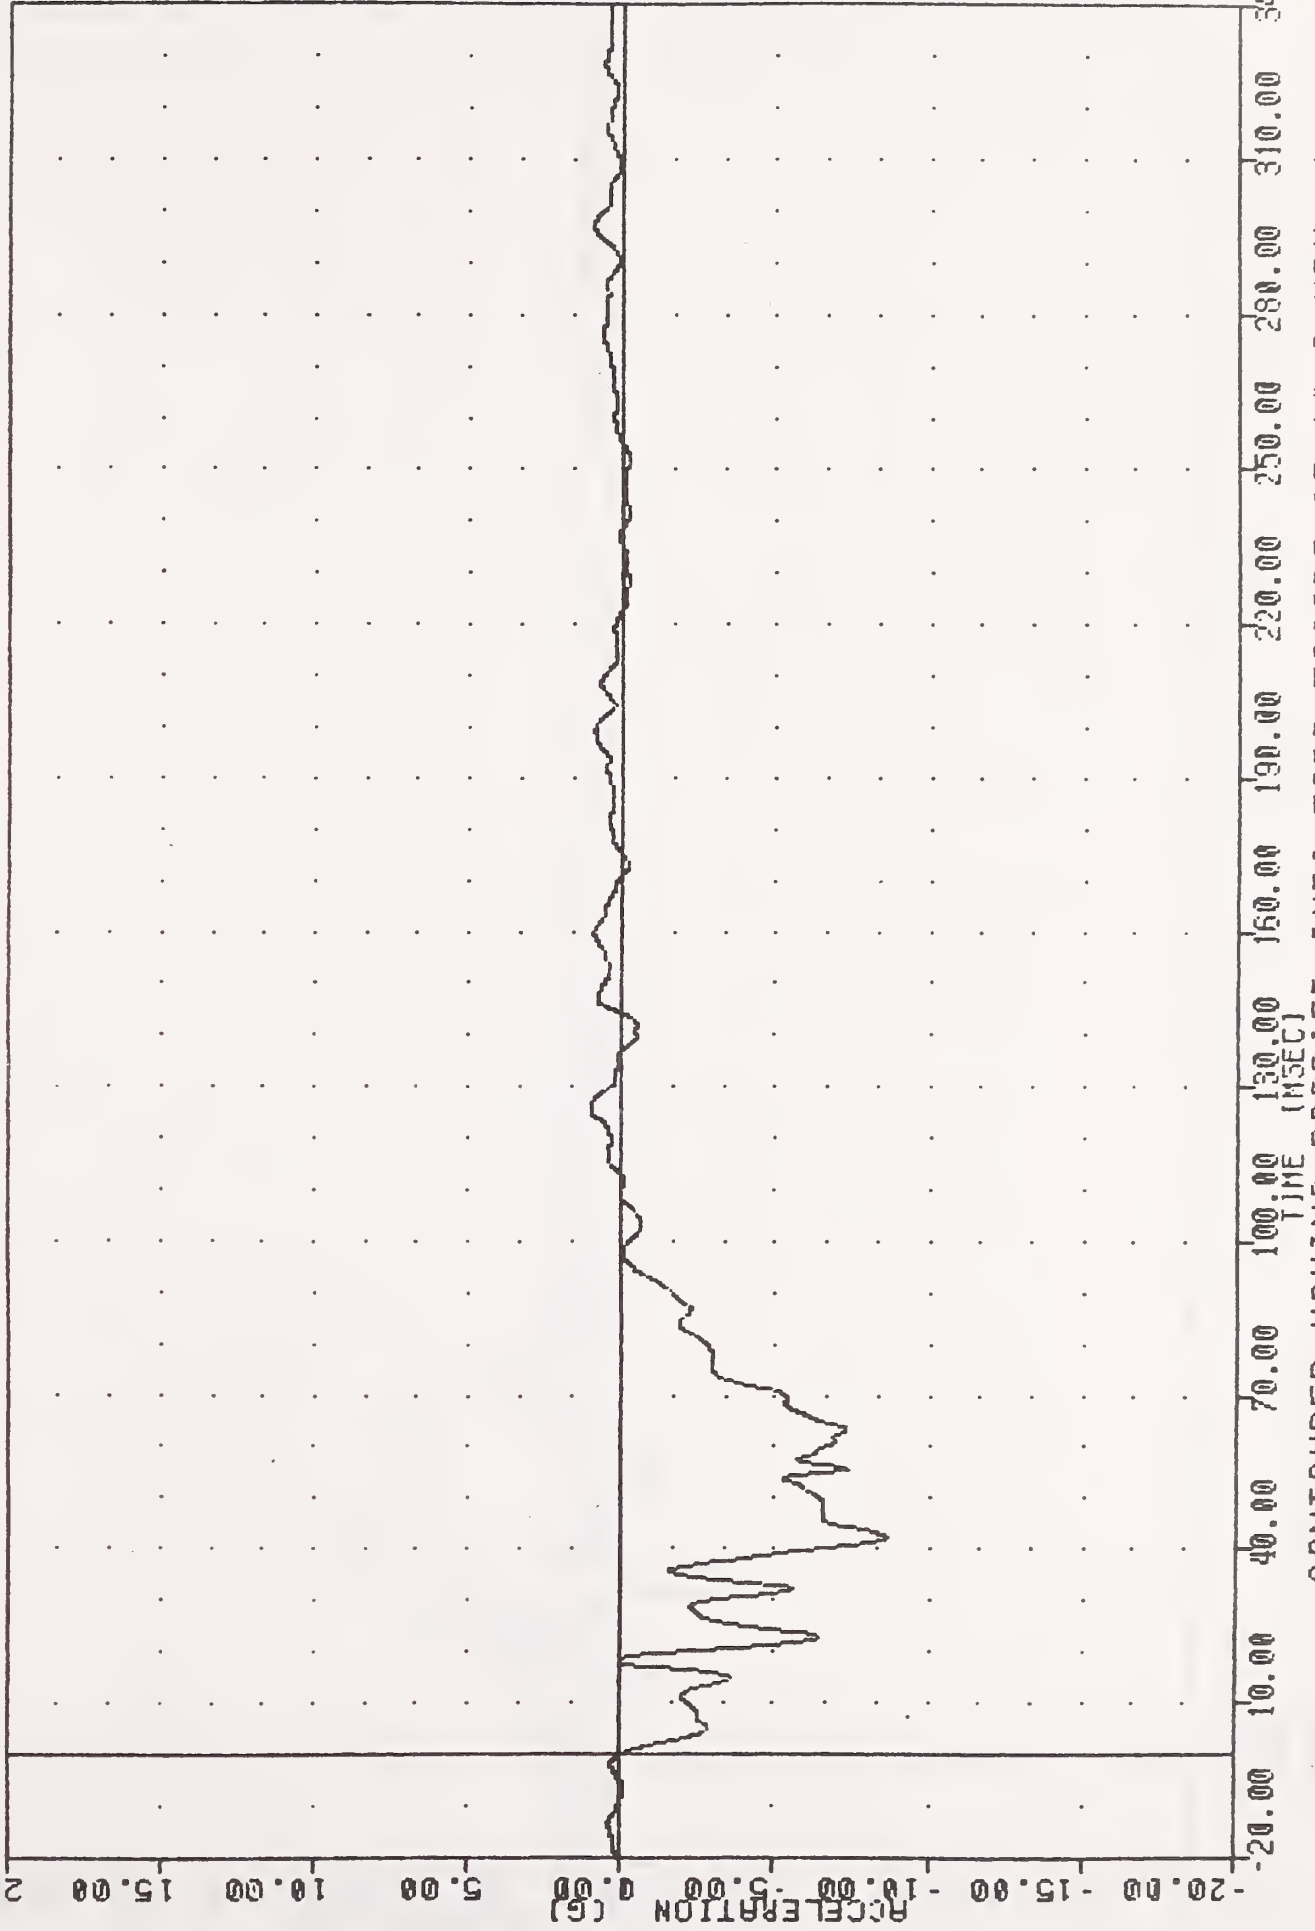
CONTOURED MOVING BARRIER INTO FORD ESCORT AT 14.2 MPH *1
VEHICLE CG X-AXIS ACCELERATION (IMPACT DIRECTION)

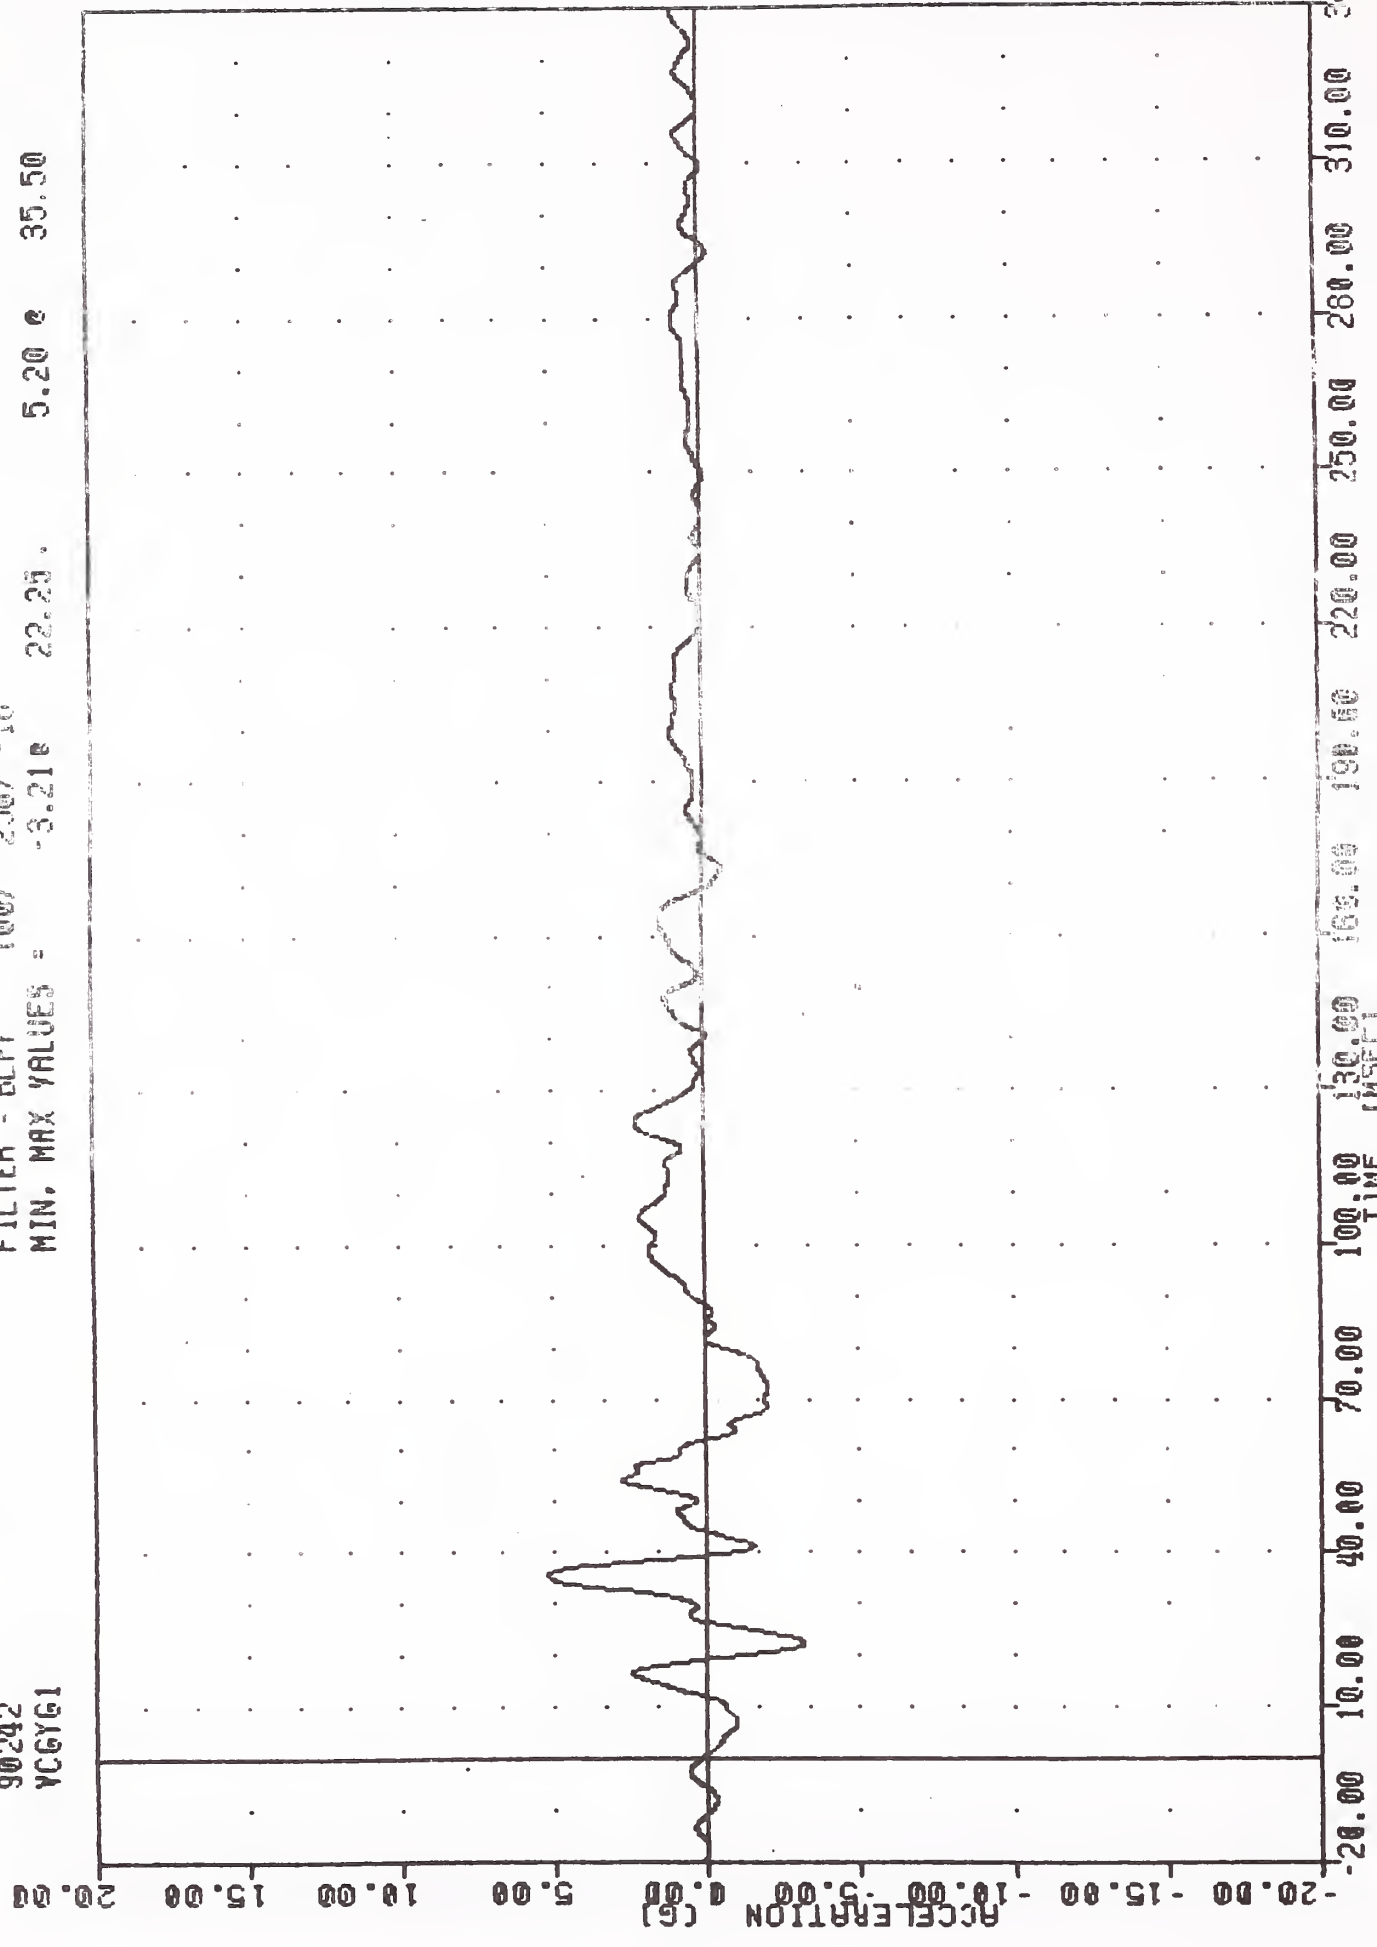
CONTOURED MOVING BARRIER INTO FORD ESCORT AT 14.2 MPH #1
 VEHICLE CG Y-AXIS ACCELERATION (PERPENDICULAR TO IMPACT DIRECTION)

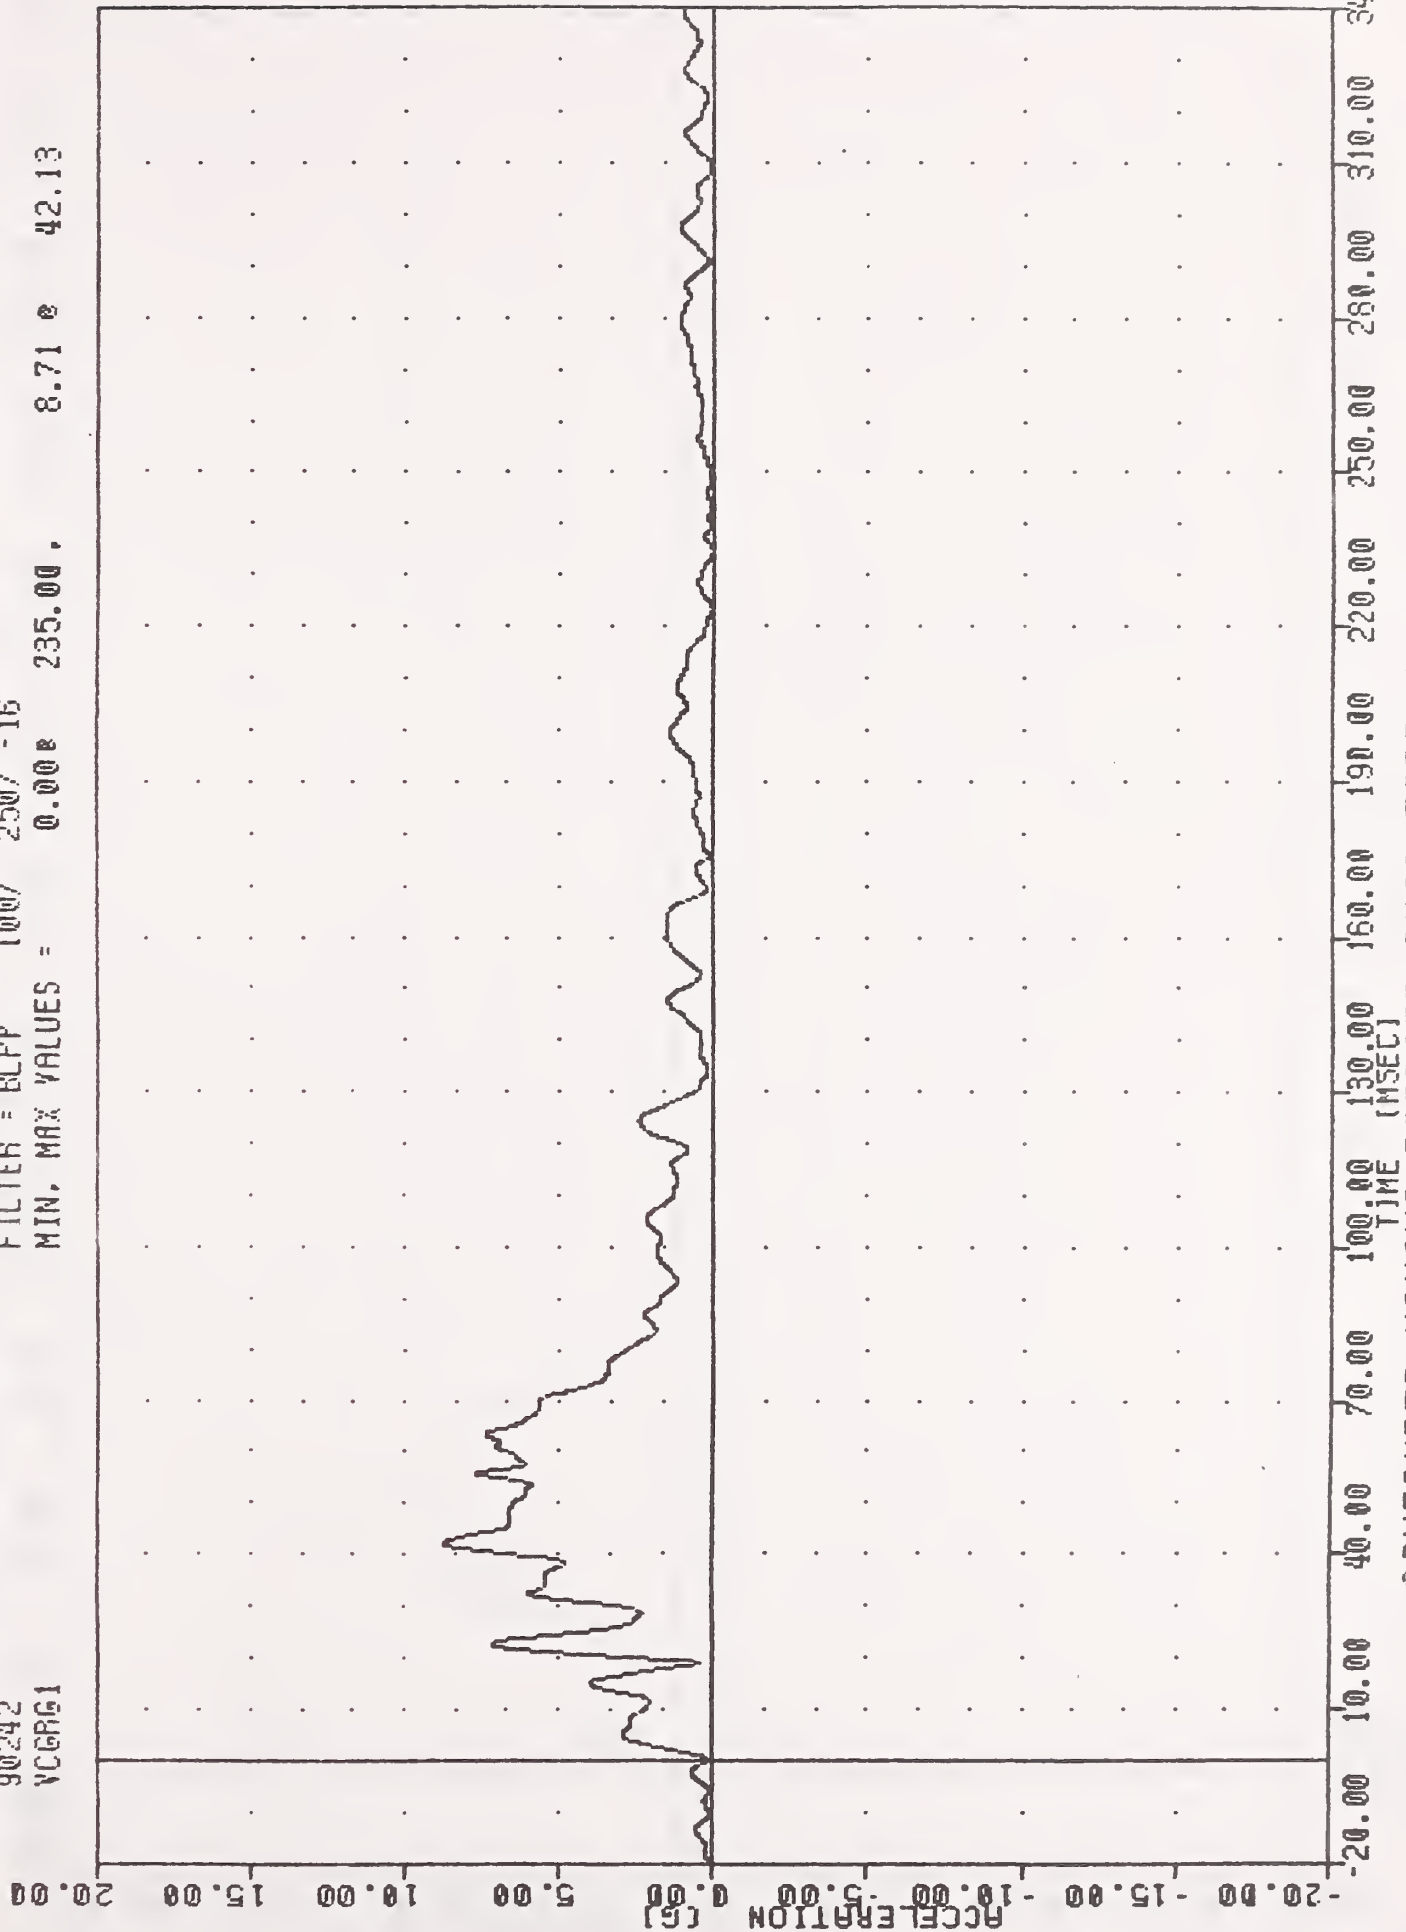
CONTOURED MOVING BARRIER INTO FORD ESCORT AT 14.2 MPH #1
 VEHICLE CG RESULTANT ACCELERATION
